# Manhole Inspection Summary

Manhole # S45II\_026MH

Insp Date: **4/25/08 1:37 PM**

**Location** Address: **Federal St**

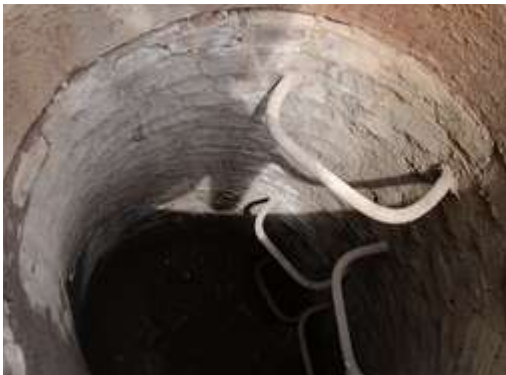
Defect 2

Infiltration: ☐ None ☒ **Joint** ☐ Cracks ☒ **Mortar** ☐ Roots ☐ Wall

Infiltration: ☐ None ☐ Joint ☐ Cracks ☐ Mortar ☐ Roots ☒ **Wall**

Infiltration

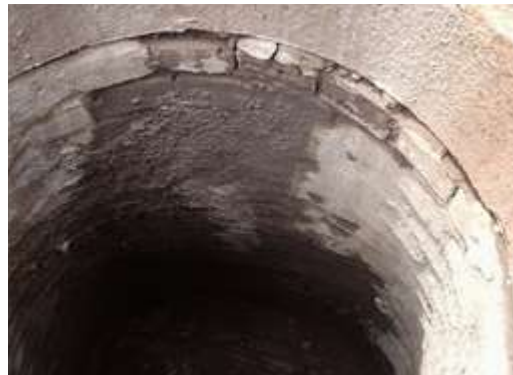
Defect 1

Condition: ☐ Sound ☐ Cracked ☐ Root Intrusion ☒ **Loose Brick** ☐ Deteriorated

Deterioration

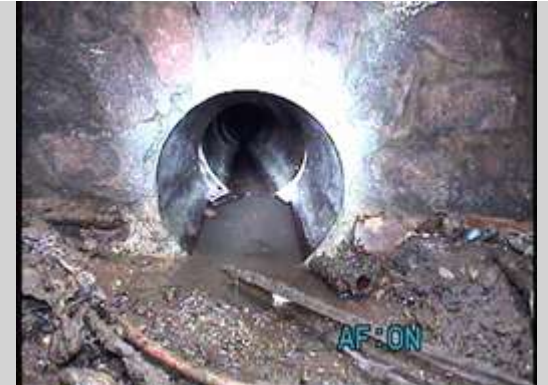
12 O'Clock Outflow

8 in. Circular Gravity Sewer  
Pipe Out @ 12 O'Clock

Infiltration: **None** Pipe Seal Cond: **Sound**
